## LD40 PU FOAM

**The Client:** Bawe Jem / MIP.

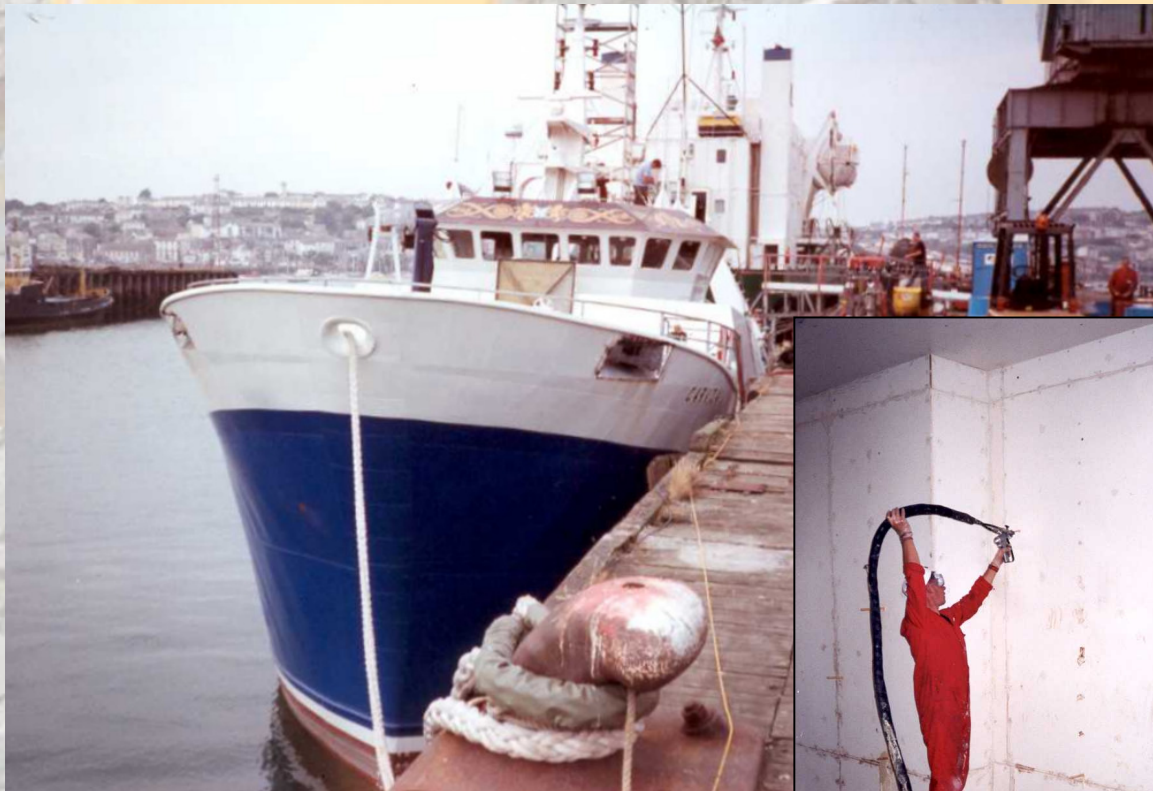
**The Solution:** The walls and ceiling of the 12m x 7m room were lined with timber and the floor concreted. **Isothane LD40** was used to fill the void behind the panels and between the panels and the hull. To help plan the installation, a metal rod was used to gauge the varying depth of the void.
