**The Client:** Austin Reed, Thirsk.

**Contractor:** McConnell Seamless Roofing

**The Problem:** The existing silicone system on a 6000m<sup>2</sup> roof had started to leak owing to general degradation and specific problems with bird attack.

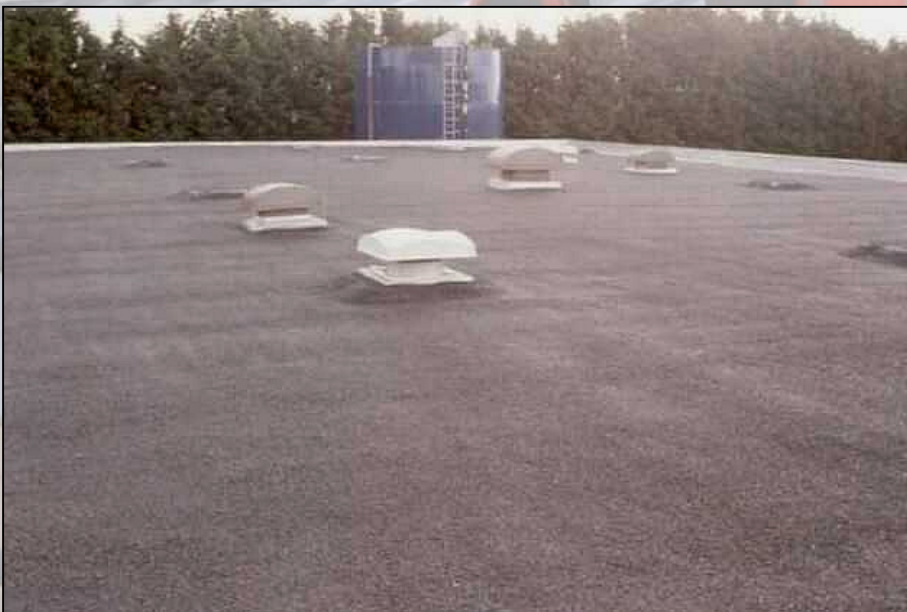
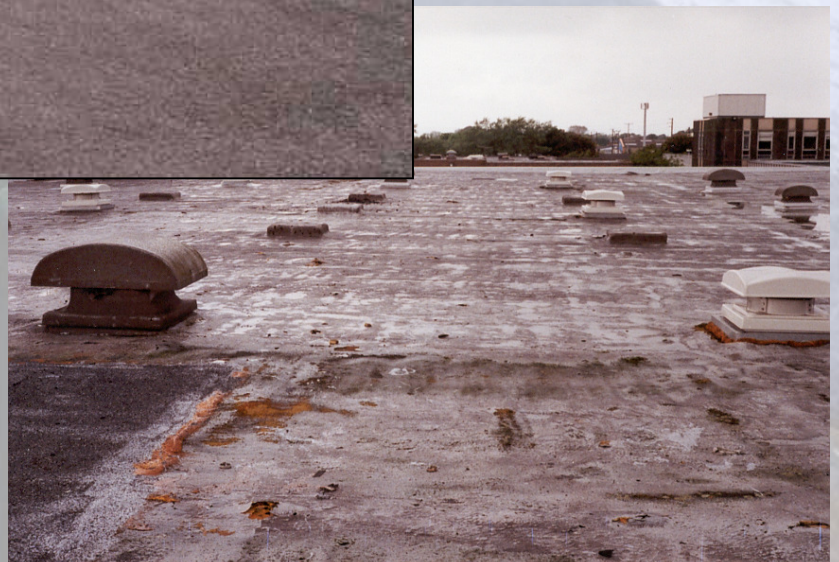
**The Solution:** With proper preparation and priming, **ISOTHANE EMA** was proven to adhere well to the existing silicone layer. Local repairs were carried out and **ISOTHANE EMA** applied at a rate of 1 litre per square metre with reinforcement to upstands only. To provide additional protection the coating was blinded with slate granules while partially cured.
